Gingin Regional Landfill (MS796)

Fernview Environmental Pty Ltd

Compliance Assessment Report (2025)

JBS&G Australia Pty Ltd | 67366 | Rev 0

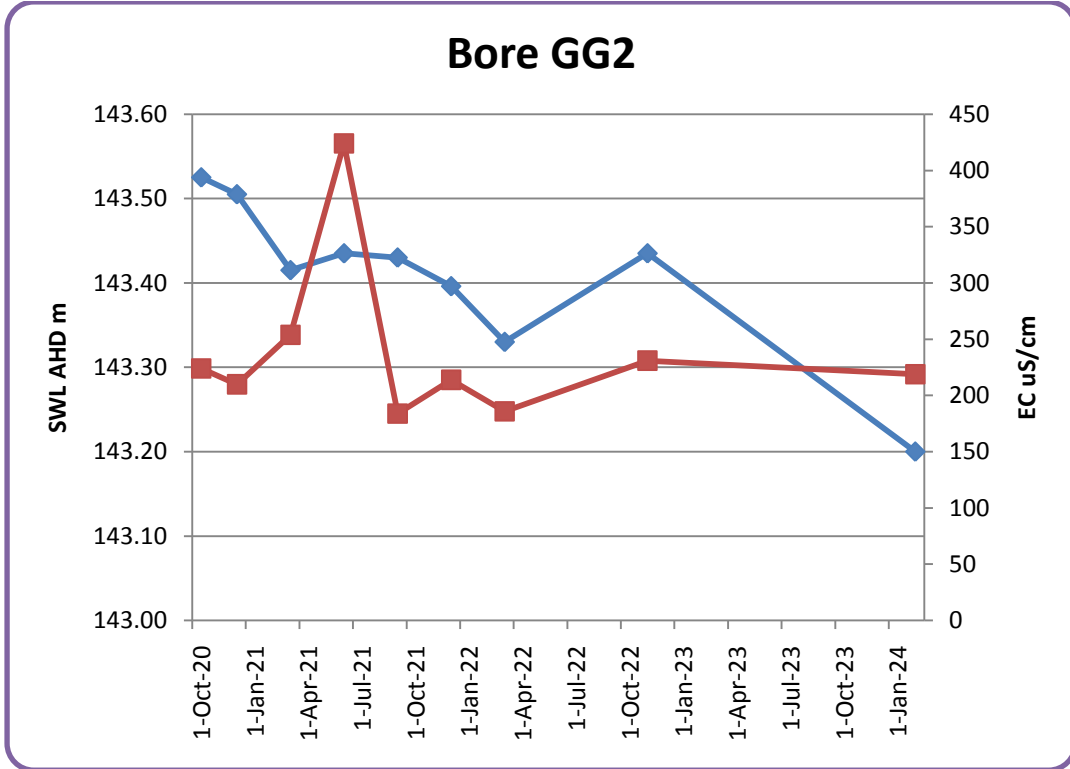
The following plots present the trends in groundwater level and quality (using TDS as a marker) and water level variations over time.
